Winter 2024.

Noosa's Huon Mundy reefs update

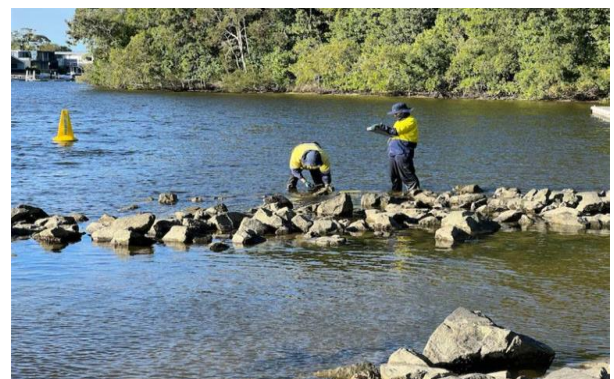
For this reason, the reefs are monitored (Figure 2) along the inner margins (closer to the shore and generally shallower), outer margins (furthest from the shore and generally deeper) and on top of the reefs (where reef exposure is generally the highest). Monitoring revealed that while oyster densities vary across a reef's profile, the density of oysters across the profile continues to increase.

Figure 2 Ecological Service Professionals monitor Noosa Sound West. Photo M Connell

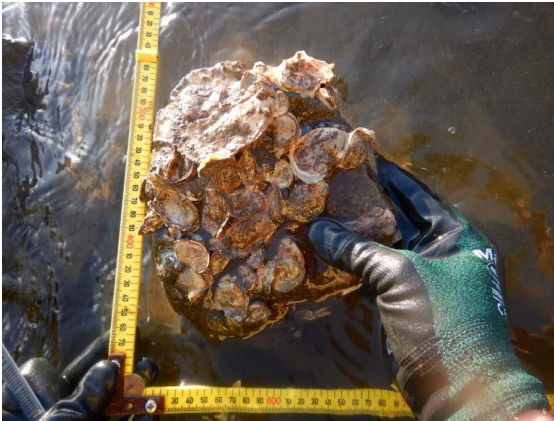
The median size of oysters growing in the restoration areas has increased from 21mm in September 2023 to 24mm in June 2024 (Figure 3). The Rock Oysters surviving on the reef structures generally had a similar size range to that recorded on remnant rubble and structured habitats, though the density was much greater on the reef structures.

Figure 3 Oyster size measurement Photo S Walker

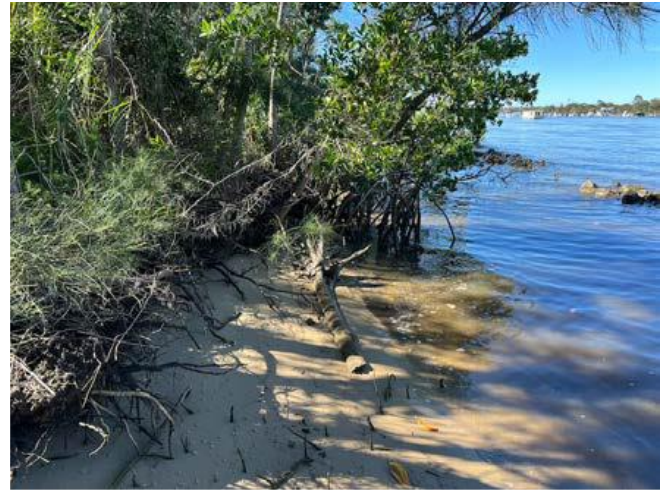
Waves generated by storms and boat wake are a major shoreline erosion problem in modern day estuaries. Noosa is no exception. For example, erosion at Goat Island is undercutting the southern bank (Figure 4), causing trees to die and collapse into the river. The exposed sediments are then readily washed away, exacerbating river turbidity and sediment levels. A common response is often to fortify the shoreline with rock seawalls, or other hard materials, which can increase wave refraction, which exacerbates erosion elsewhere.

Figure 4 Erosion and undercutting at Goat Island. Photo S. Walker

Shellfish reefs, however, can be used to great effect in the fight against coastal erosion. They can be designed to attenuate waves while minimising wave refraction. They also provide benefits to nature. The shellfish reefs at Goat Island are showing just that. Monitoring has shown that erosion shoreward of the Goat Island reefs has been halted and sand is building up between the shoreline and the reefs. Mangrove propagules have also begun to settle and establish on the sand build up, adding to the shoreline protection offered by the reefs. However, between the reef patches and up and downstream of the reefs, wave action continues to erode and threaten Goat Island.

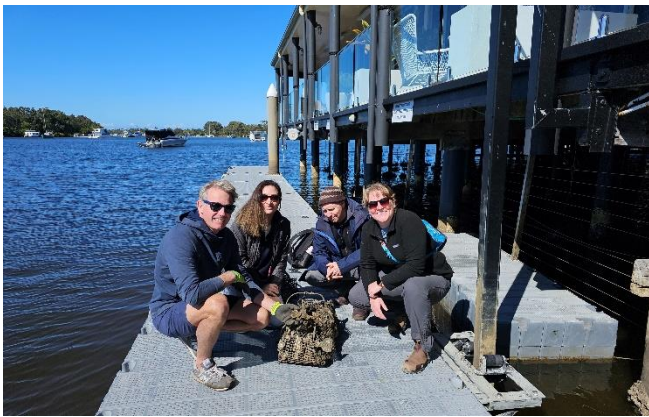
Figure 5 Oyster gardens are used as a window to the underwater community Photo M. Connell

Now well into its second season, Noosa's Oyster Gardening Project continues to grow oysters for Noosa's Huon Mundy Reefs. Oyster gardens also provide a window into the unseen wildlife found in the Noosa River. Led by an active crew of river guardians from the Noosa Integrated Catchment Association (NICA), along with their large and committed team of oyster gardeners, oyster gardens continue to quietly achieve amazing outcomes. This includes the use of the oyster gardens as an educational tool to help visitors understand the complexity of the underwater community in the Noosa River (Figure 5).

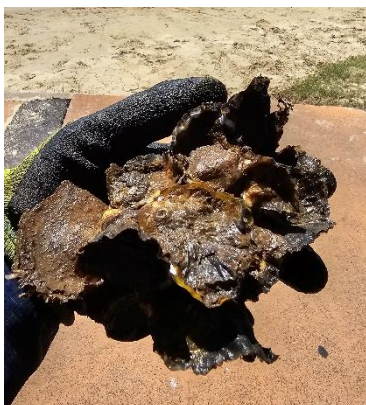
Despite high sediment loads and freshwater levels in the Noosa River over the summer of 2023-2024, NICA reports that the oyster gardens continue to thrive (Figure 6). Along with Rock Oysters, Pearl Oysters tend to colonise and dominate many oyster gardens. Pearl Oysters grow faster and larger than Rock Oysters, so can readily take over an oyster garden, leaving less space and food for Rock Oyster gardens.

Figure 6 Oyster gardening rock oyster "clump" Photo M. Connell

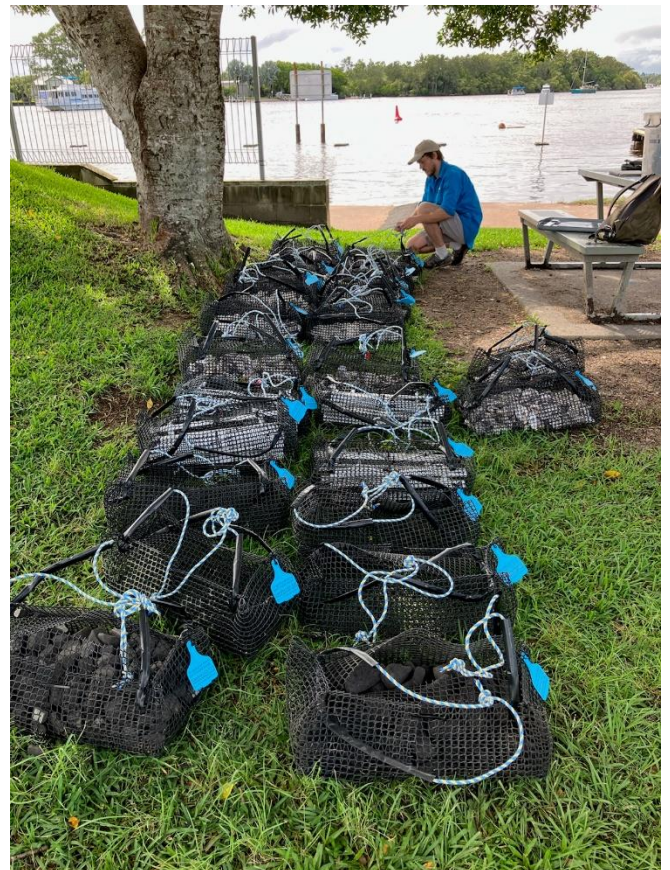
NICA has also established additional oyster gardens (Figure 7), as experimental plots as we seek to understand what surfaces oysters prefer to settle on (for example, rough or smooth oyster shells). The team has also commenced experiments to reveal at what stage of their life oysters become less vulnerable to predation, particularly from fish. This will help us identify the best moment to release oysters from the gardens back into the restored rock oyster reefs.

Figure 7 Setting up additional oyster gardens for settlement trials Photo R. Howard
